FINAL REPORT FOR STA-2A NDT TESTING

MORTON THIOKOL, INC.

FINAL REPORT ON STA-2A NDT TESTING

25 NOVEMBER 1987

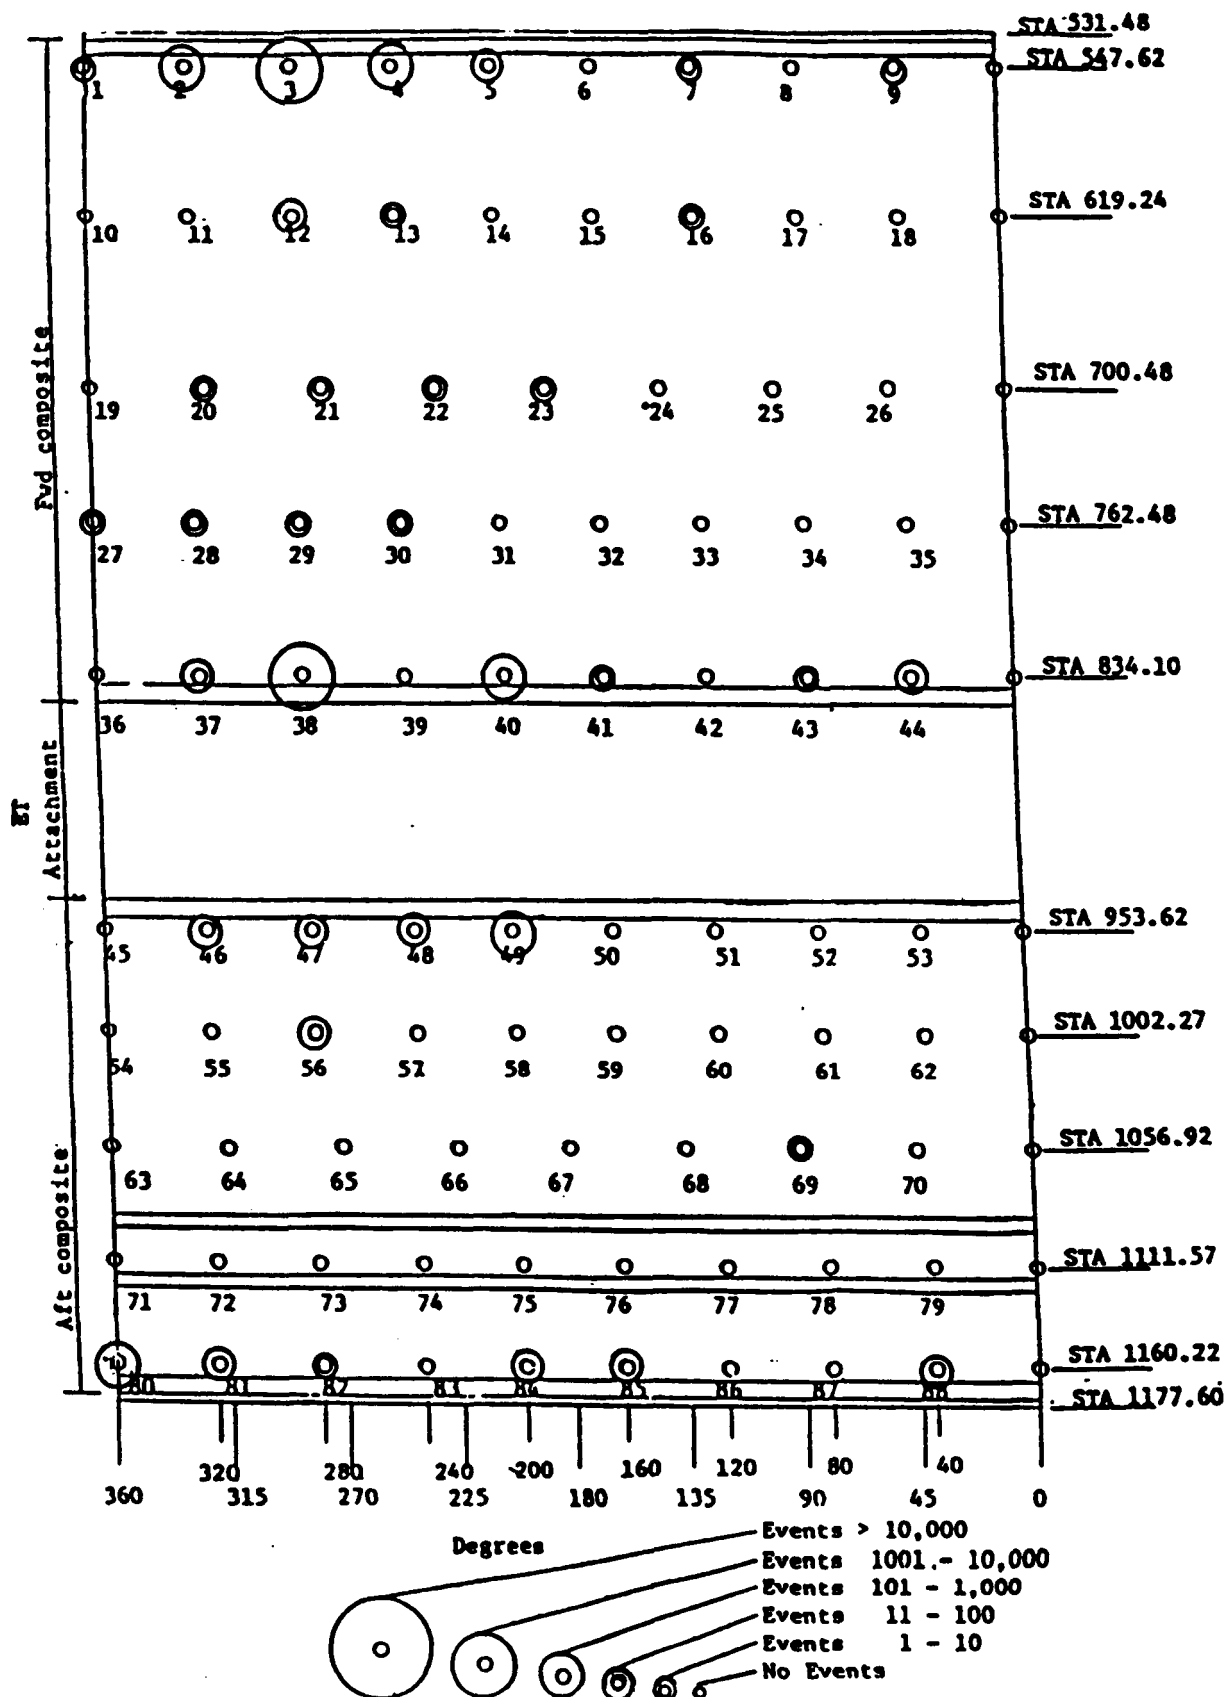
FIGURE 21. TOTAL AE EVENTS PER SENSOR
TEST PHASE 6

The AE data shows no significant defect growth. The Aft Transition region had unusual emissions during the load hold. However, the low number of total events is not indicative of significant damage. Figure 21 shows the total event range of each sensor location. All sensor locations had good event roll off during load hold. Sensor locations 4 and 20 had events during download of pressure. A Pulse Echo inspection found no damage in this area. This small number of events could be noise from a load cell.

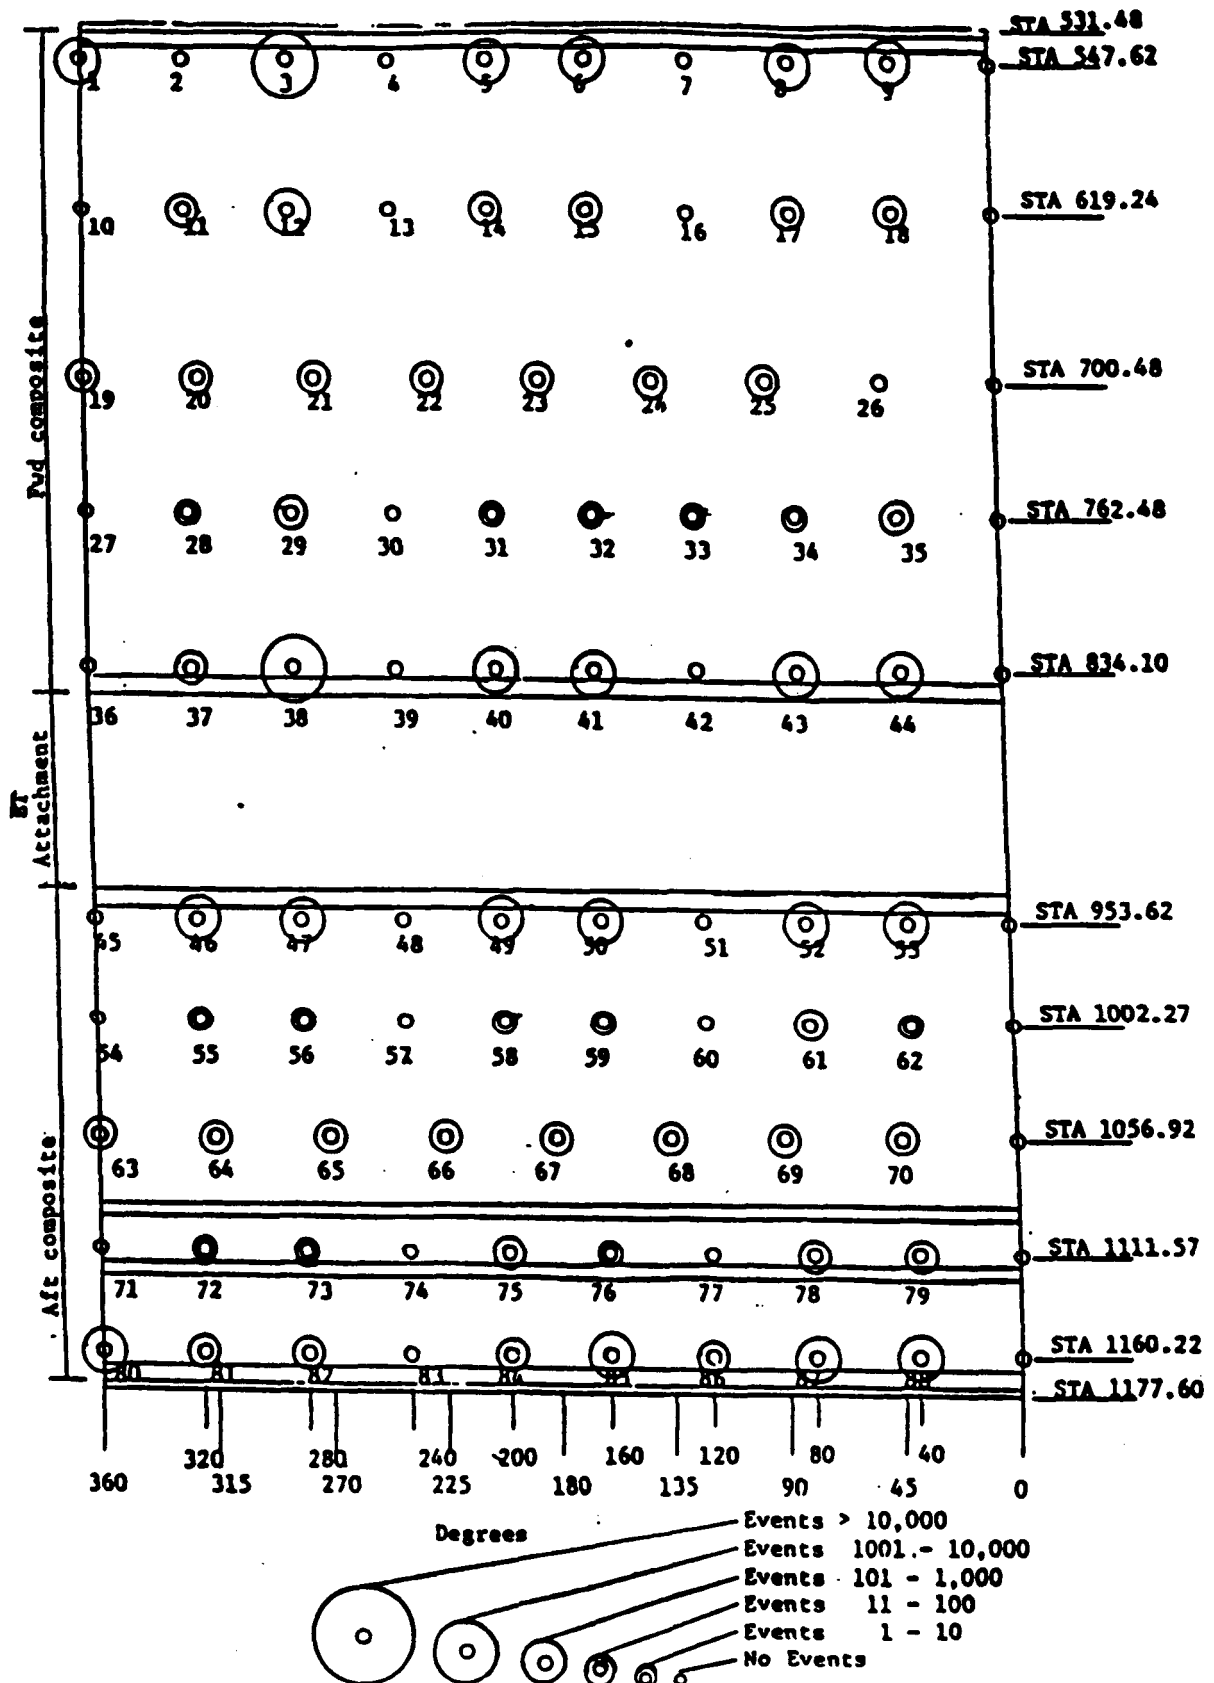
FIGURE 23. TOTAL EVENTS PER SENSOR LOCATION
TEST PHASE 7A

This test was performed on 15 April, 1985 per "Test and Checkout Procedure FWC-TCP-013". Test loads are shown in Figure 22. This test was performed in two parts due to premature automated load system dumping. Acoustic Emission monitored both test loads. The AE data showed activity near sensor locations 27, 30, 54, 60 and 71. The event range activity of each sensor is shown in

Figures 23 and 24. The AE events versus load curve is shown in Figures 25 and 26. Figure 26 shows a non-linear increase in events after 100 percent load. The early event activity came from the previously mentioned sensor locations. This gave a felicity ratio of 0.91. This data indicates damage was near sensor locations 54, 60 and 71. The relief valve noise masked emissions during download of pressure.

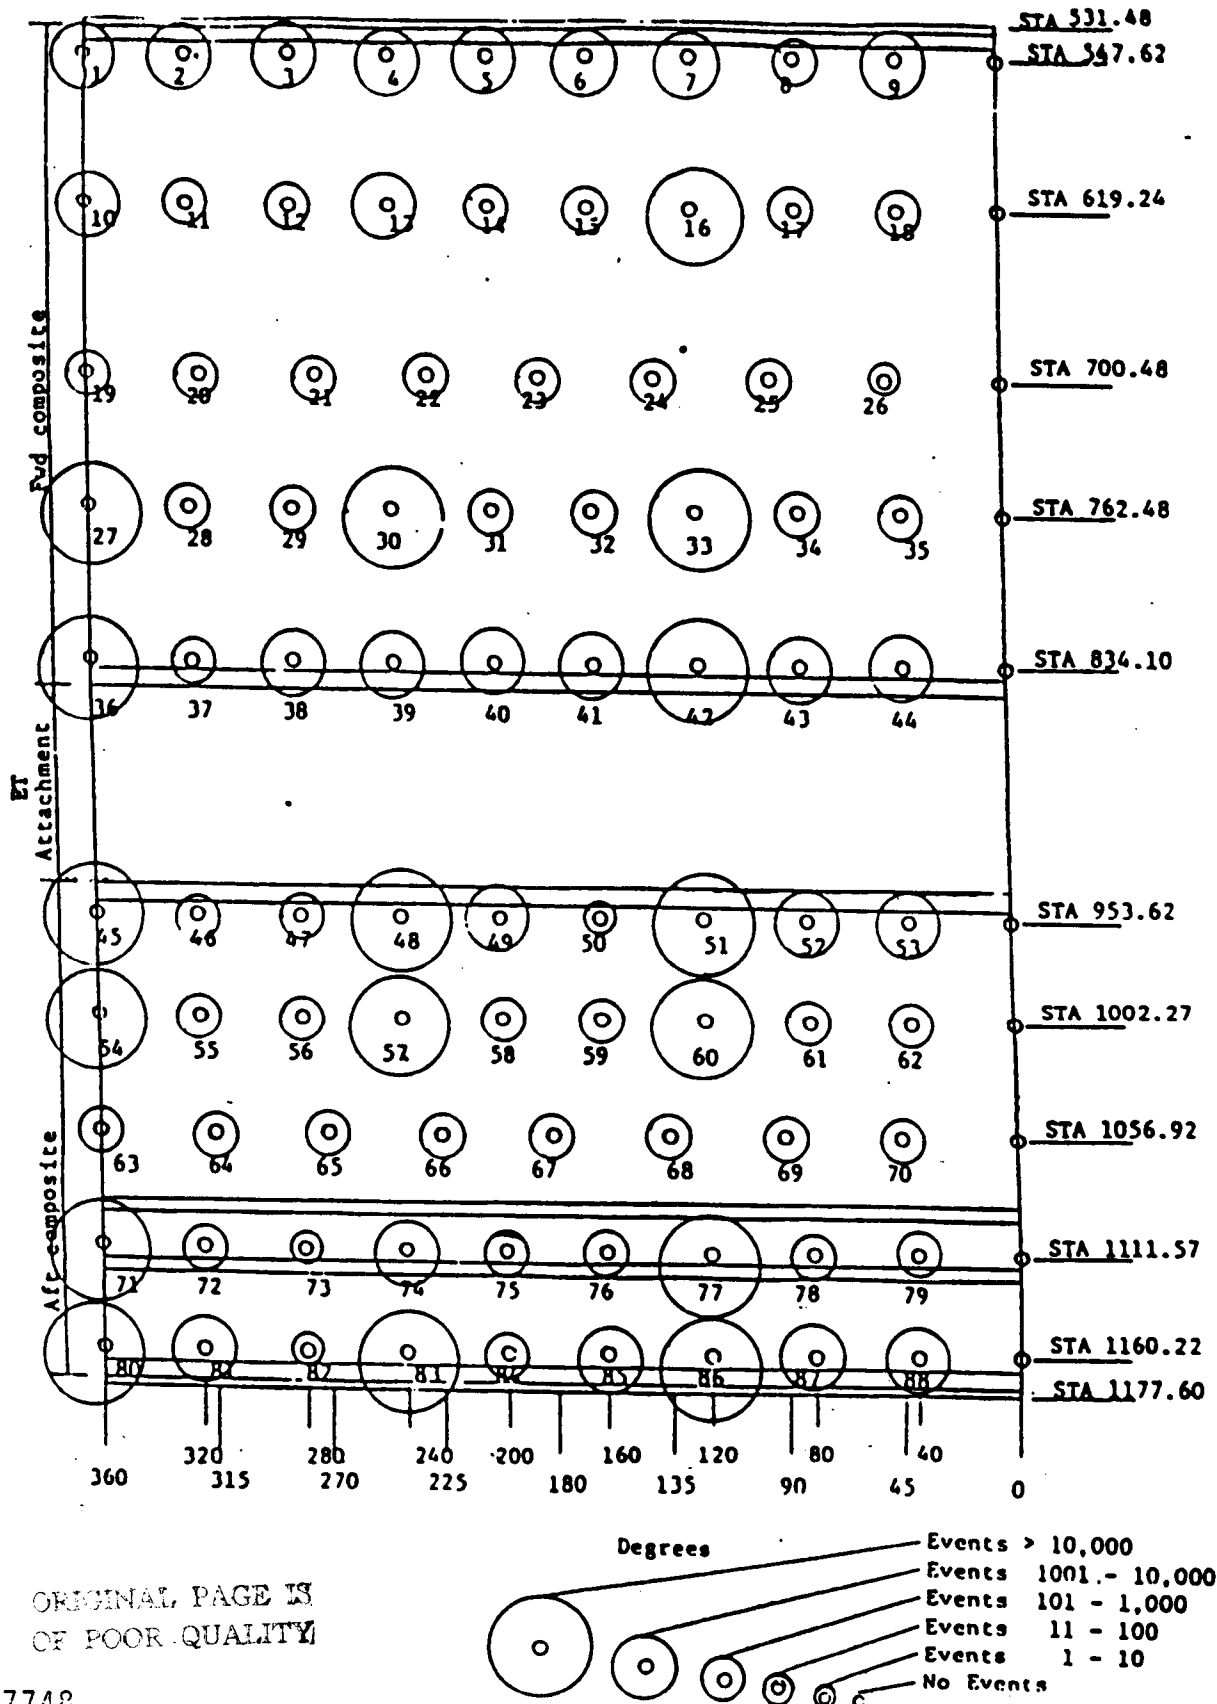
FIGURE 24. TOTAL EVENTS PER SENSOR LOCATION
TEST PHASE 7B

The total number of events are very low. Active sensors 3 and 38 shows no visual damage. Phase 7B shows non-linear growth increasing at 100% load. Active sensors 27 and 30 shows no damage to account for activity. Active sensors 54 and 60 visually shows the machined off Stiffener Ring debonding from the case. The first helical layer is debonding from the case. Activity from sensors 71 and 74 is from the debonding of the Stiffener Rings from the case. The felicity ratio of 0.91

indicates damage. Pulse Echo points scanned after the test phase shows a general change in waveforms. There is a major delamination of the Forward Stiffener Ring to case.

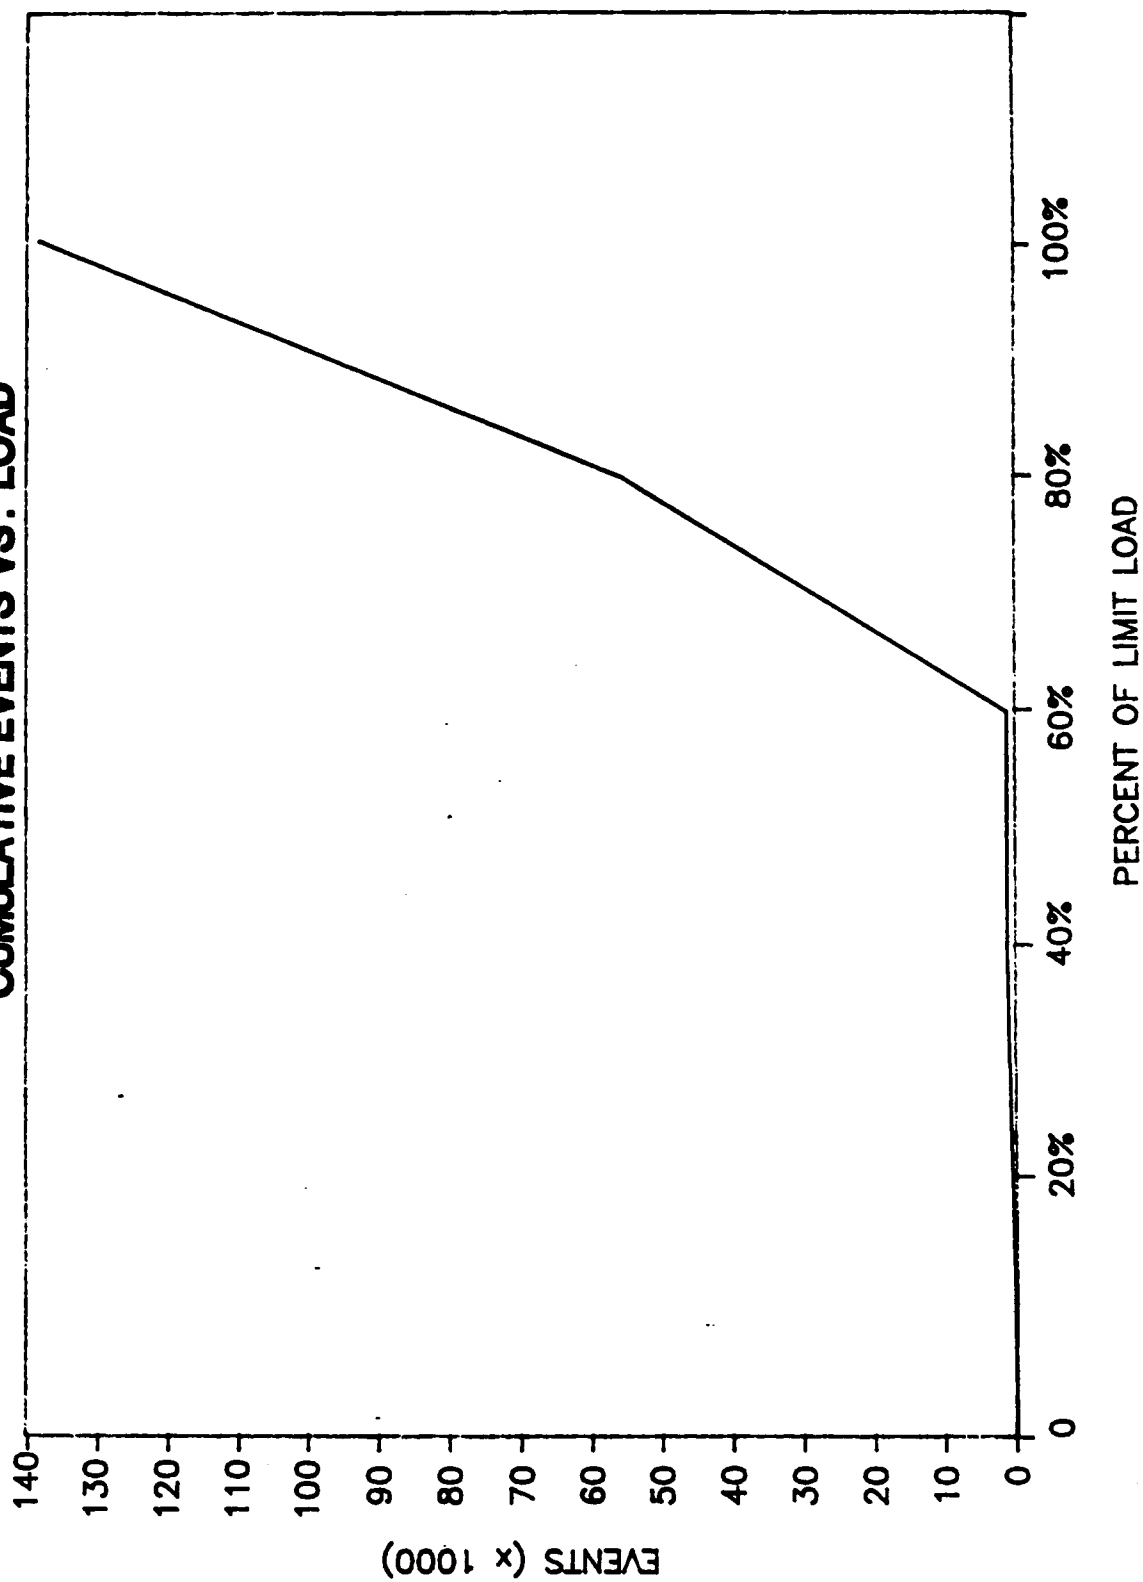
FIGURE 40. STA-2 PHASE 9C-2ND LOADING

The second loading of STA-2A occurred 17 May, 1985. The test was stopped due to high AE activity and unusual deflections in the case. The applied loads are shown in Figure 35. The real time AE data shows significant defect growth occurring in the Aft Segment, Aft Transition region near 160 degrees. Figure 40 shows the AE events versus load. A non-linear increase in AE events occurred when the load increased from 60 to 80 percent. During the 80 and 90 percent load hold the emissions continued to increase for the duration of the hold. During the reduction of load, friction type emissions occurred in the Aft Transition region. Figure 41 shows the total event range during load hold of each sensor location. Sensors 71, 84, and 85 were the predominant regions.

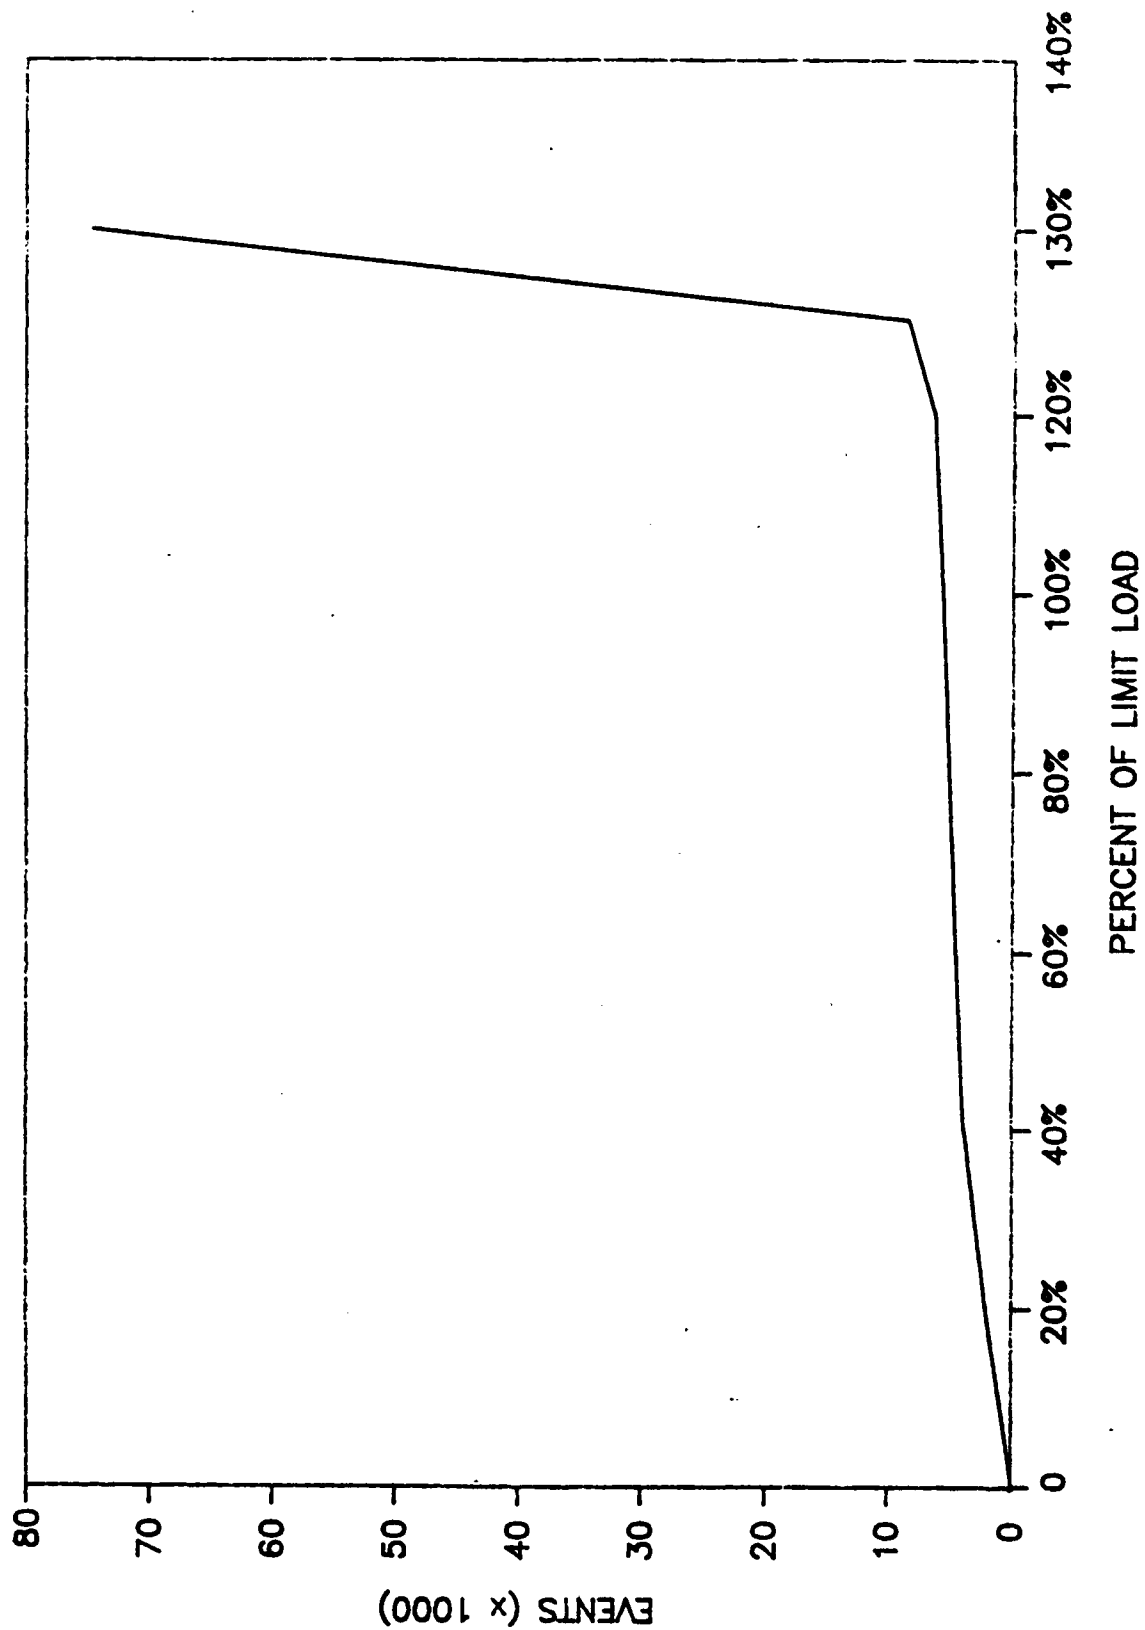
**FIGURE 50. STA-2 PHASE 9C-6TH LOADING
CUMULATIVE EVENTS VS. LOAD**

Completion of the third pre-launch ultimate stress test (sixth load) was on 24 July, 1985. AE sensor locations were changed to closely monitor the delamination growth. Figure 49 shows the new sensor locations. AE activity began to increase at the start of loading (Figure 50). From 0 to 100 percent limit load the AE data originated from the known delamination. As the load increased above 100 percent the AE activity shifted to the outside boundaries of the defect. During the loading above 115 percent limit load the AE data shows that the defect grew in the forward direction until failure. Figure 51 shows the total number of events recorded at each sensor location in the defect region. The most active areas were near sensor locations 76, 85, 86 and sensors 2, 3, and 6. Cumulative results of all Pulse Echo inspection of all AE active areas are shown in Figure 52. The Pulse Echo data confirms that delamination growth occurred in the directions AE displayed in real time. Failure occurred in the location of unusually high AE activity noted during the first loading to 90 percent limit load. The AE data showing first hit and time of flight

The AE data indicated defect growth occurring in the Aft Segment, Aft Transition region at 160 degrees. The AE began increasing sharply as the load increased above 60 percent. AE activity continued during the 80 percent load hold. The test was stopped at 107%. A Pulse Echo inspection revealed a delamination occurred from 155 degrees to 175 degrees in the Aft Segment, Aft Transition from 8 to 30 inches forward of the Aft Composite edge. The Aft Segment failed in the location previously mentioned at 129 percent limit applied load.

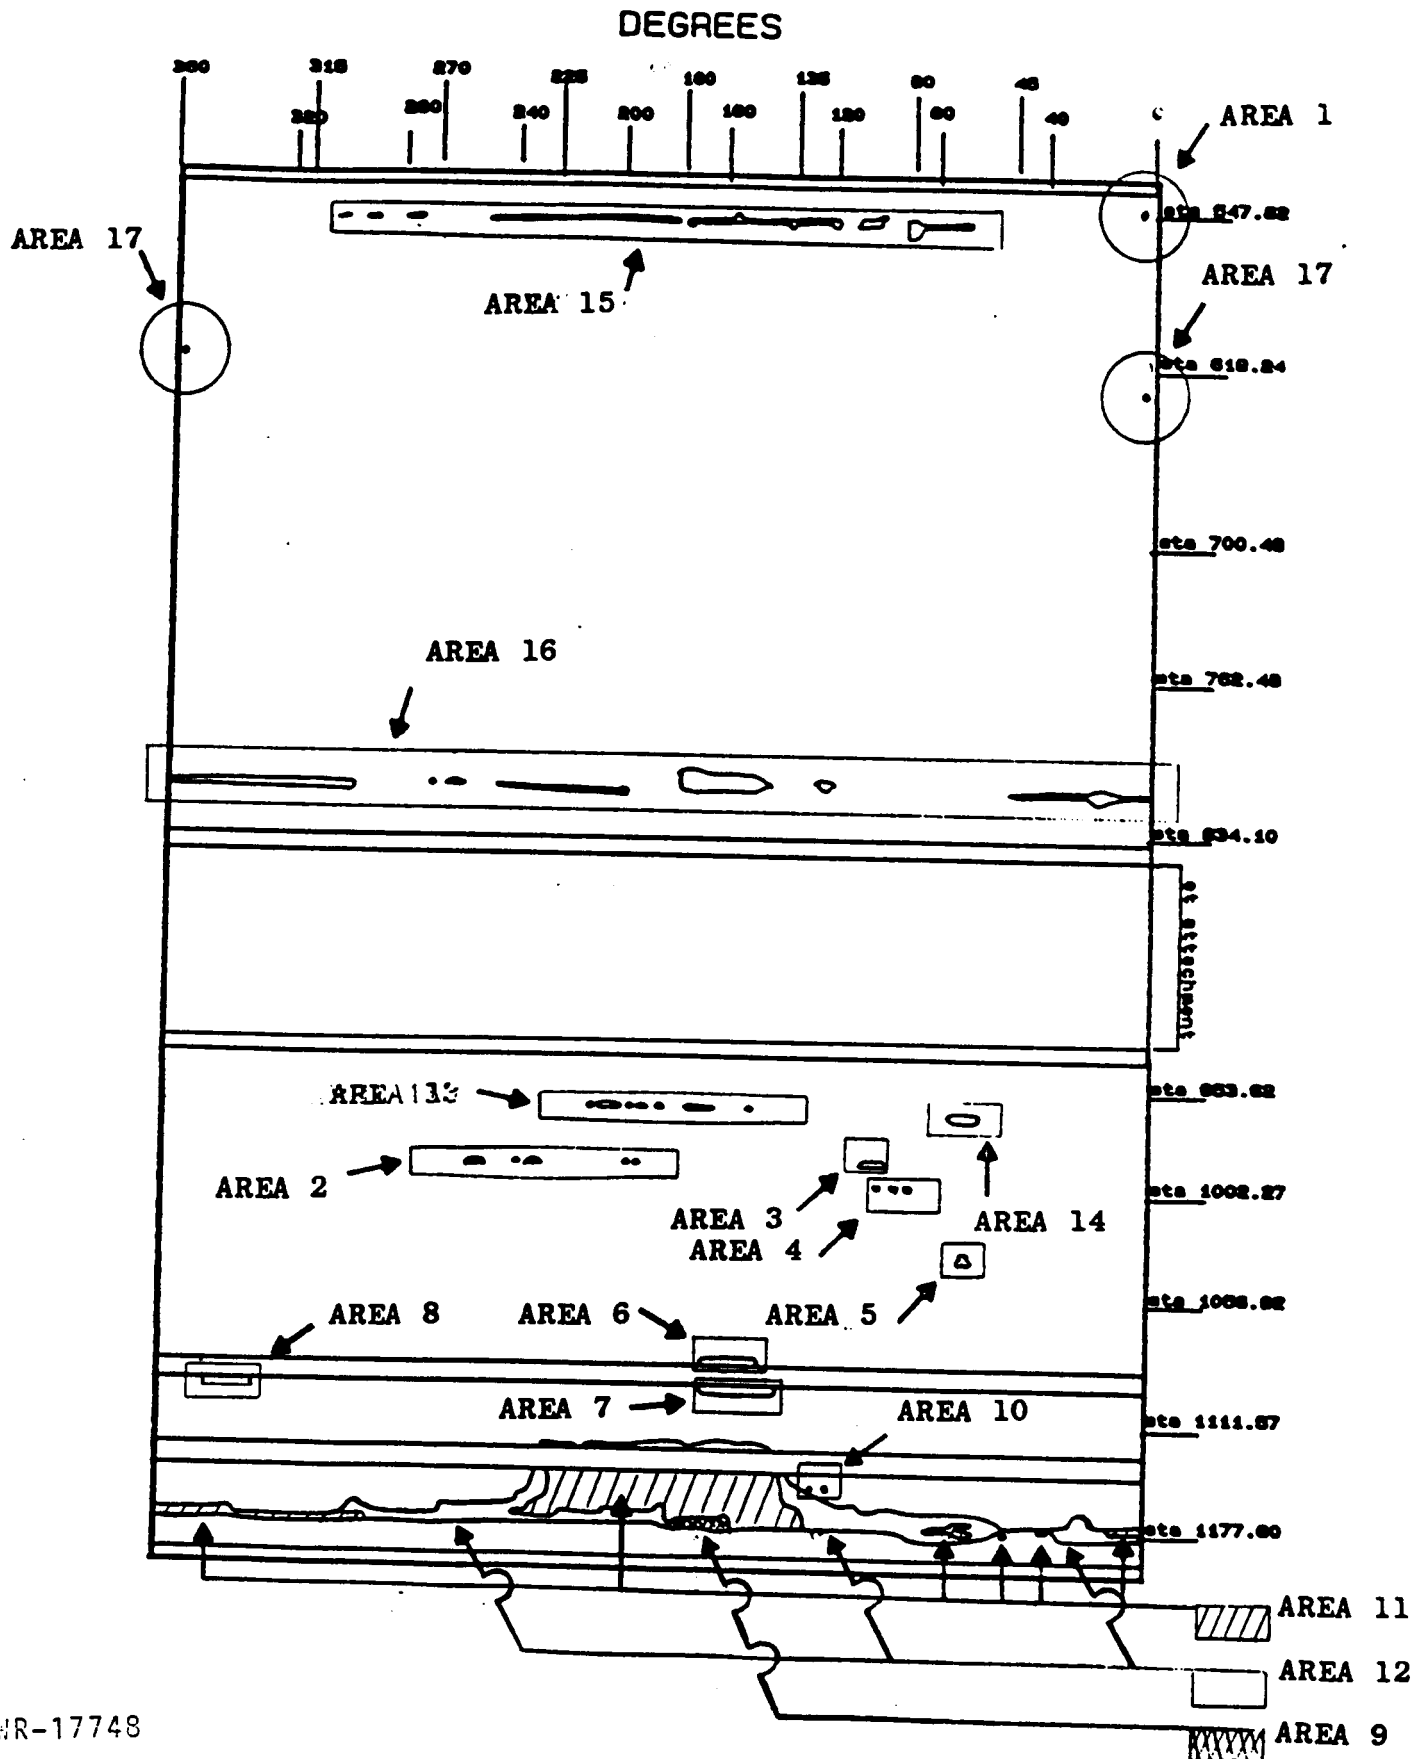
FIGURE 52. POST FAILURE PULSE ECHO INSPECTION

measurements recorded, indicate the failure occurred in the location shown in Figure 53. Figure 54 shows a topographical map of AE activity for the Aft Segment during failure load.

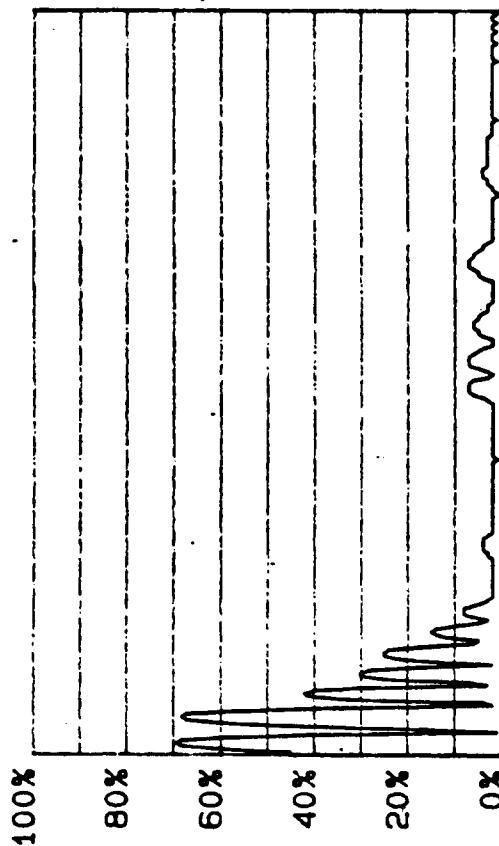
PART NO. STA-2A
 S/N Sample #9
 TECHNICIAN _____
 TEST REQ Full-Wave
 TEST LOCATION Area A

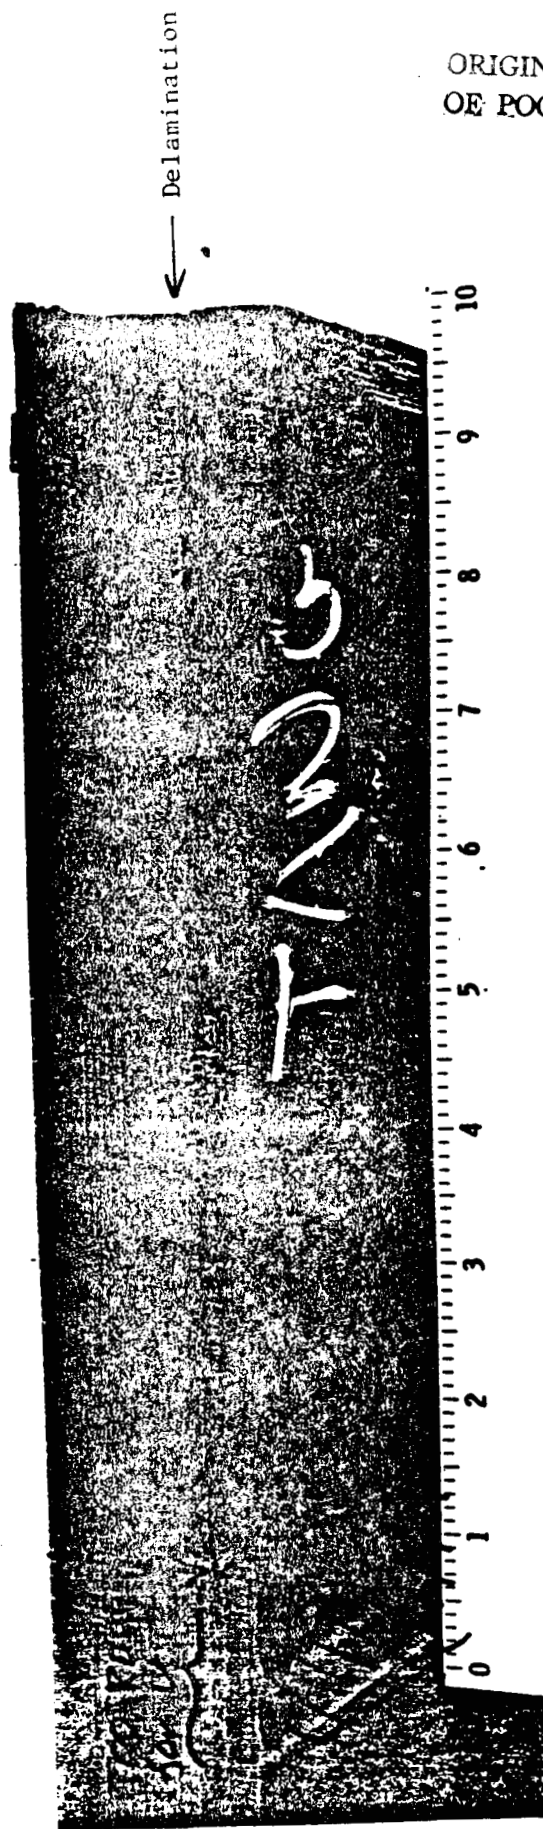
FIGURE 63. SAMPLE #17

Test sample 17 represents the forward edge boundary condition for the failure location. The forward boundary and depth information are critical for stress analysis and modeling. Figure 62 shows the sample dimensions and location of defects. Two defects are seen in this sample; Area A which is the forward boundary of the major delamination and area C which is an unbond of the Stiffener Ring build up region from the case. The Pulse Echo inspection at MSFC shows delamination growth of area A to be approximately 2 inches forward of the Stiffener Rib. Figure 63 shows a picture of this delamination. The Pulse Echo depth measurements of these flaws at MSFC gave an indication of 1.300 inches at point A and 0.530 to 0.547 inches at point B from the OD. The measured mechanical depths from the OD are 1.480 inches for point A and 0.600 inch for point B. The full wave Pulse Echo signal for location A and B are shown in Figures 64-65.

- A. Visible delam: depth mechanical 1.480" (O.D.) UT depth 1.300"
- B. UT depth .530" - .547".
- C. High UT signal over 100% S.H. in center at .065" depth.

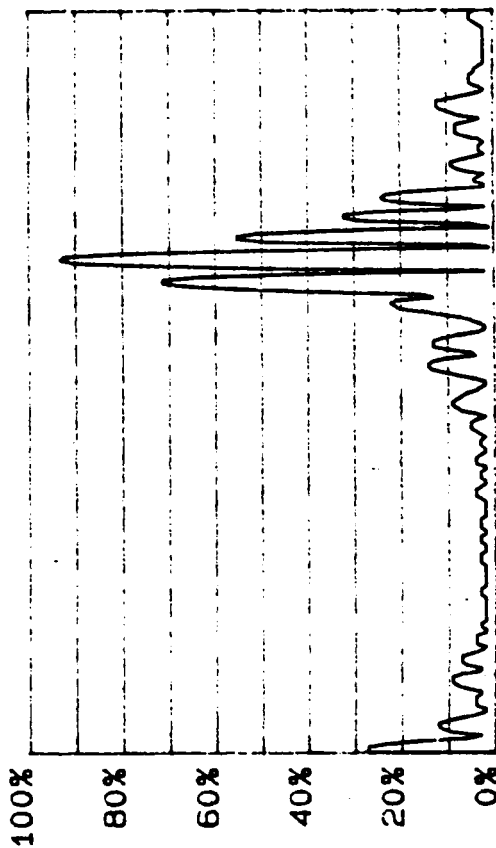
FIGURE 64.

PART NO. STA-2A
 S/N Sample #17
 TECHNICIAN
 TEST REQ Full-Wave
 TEST LOCATION A

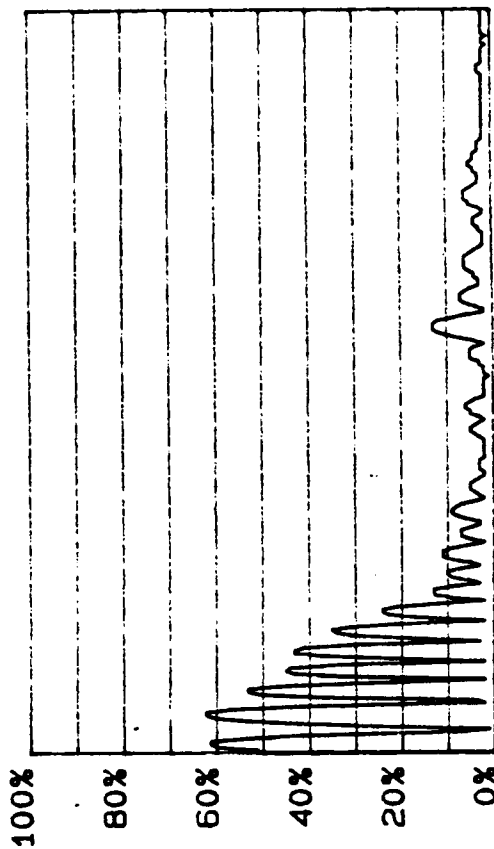
FIGURE 73.

Sample 19 was chosen because this was an AE active area generating friction type emissions. The Pulse Echo inspection at MSFC indicated this was a circumferential termination point of the major delamination. The origin and dimensions of the sample are shown in Figure 70. The reason for friction type AE are quite obvious from Figure 71. The interesting observation from this sample is that the Pulse Echo inspection from the OD showed areas A, B and C but did not show delamination F, G or H. The high porosity in the plastilock in this location blocked the detection of the delamination. Figures 72 and 73 show the waveforms recorded at the A and B locations.

PART NO. STA-2A
 S/N. Sample 19
 TECHNICIAN
 TEST REQ Full-Wave
 TEST LOCATION B

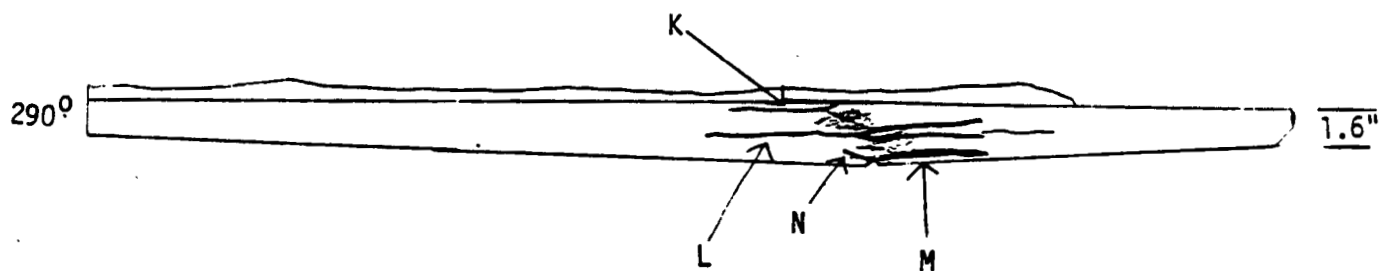
FIGURE 74. SAMPLE #20

Figure 74 shows the origin and dimensions for sample 20. This sample was chosen because it was typical of the signals we thought represented areas of high porosity in the plastilock. Figure 75 shows the porosity in the plastilock, but it also shows delaminations below. The waveform from location A shows the peaks located at 0.470 inches from OD. A mechanical measurement shows the
